Section 6.3

1 Units of the ADC Compact Digitizer (Overview)

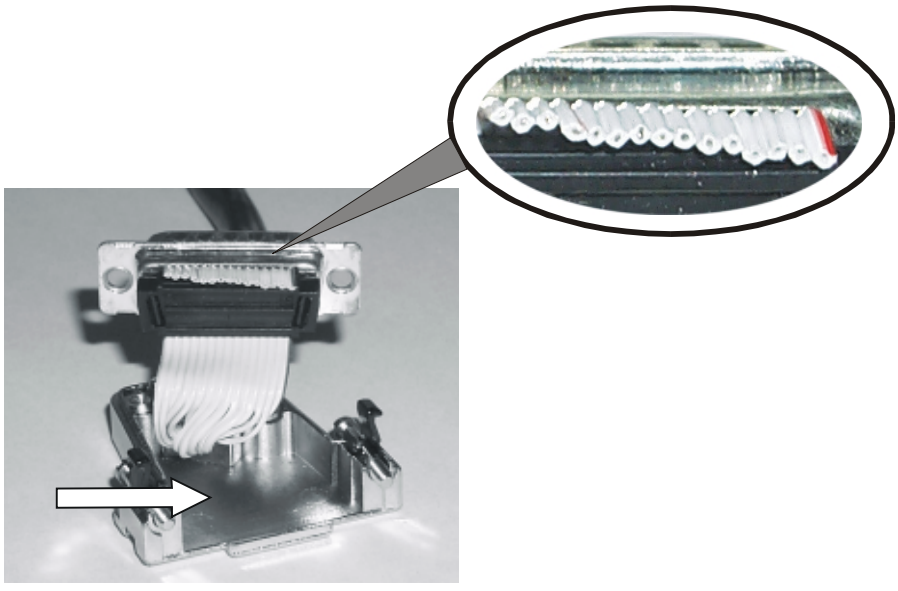
Figure 3

Wires of the ribbon cable (see spot) come into contact with the metal casing of the plug (see white arrow).

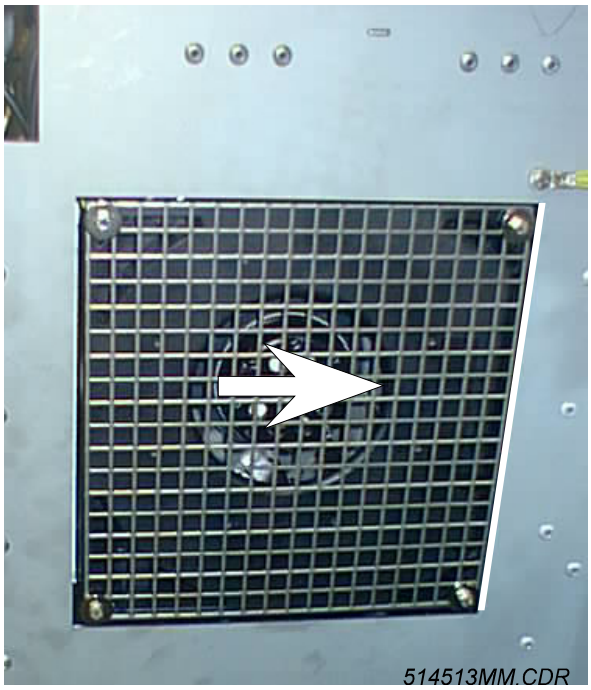
Figure 5

Light may leak in through the vents in the area of the fan of the Erasure Unit (right hand fan edge).

Loosen the fan screws, push the fan and the grid fully to the right and tighten the screws again, see

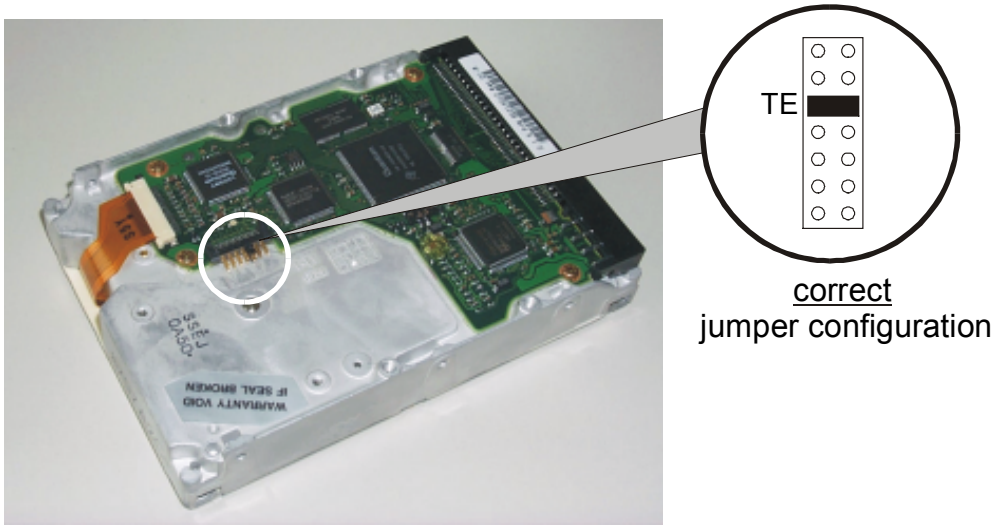
Due to production reasons the jumper configuration of the hard disks may vary.

The correct jumper configuration is shown in the figure below.

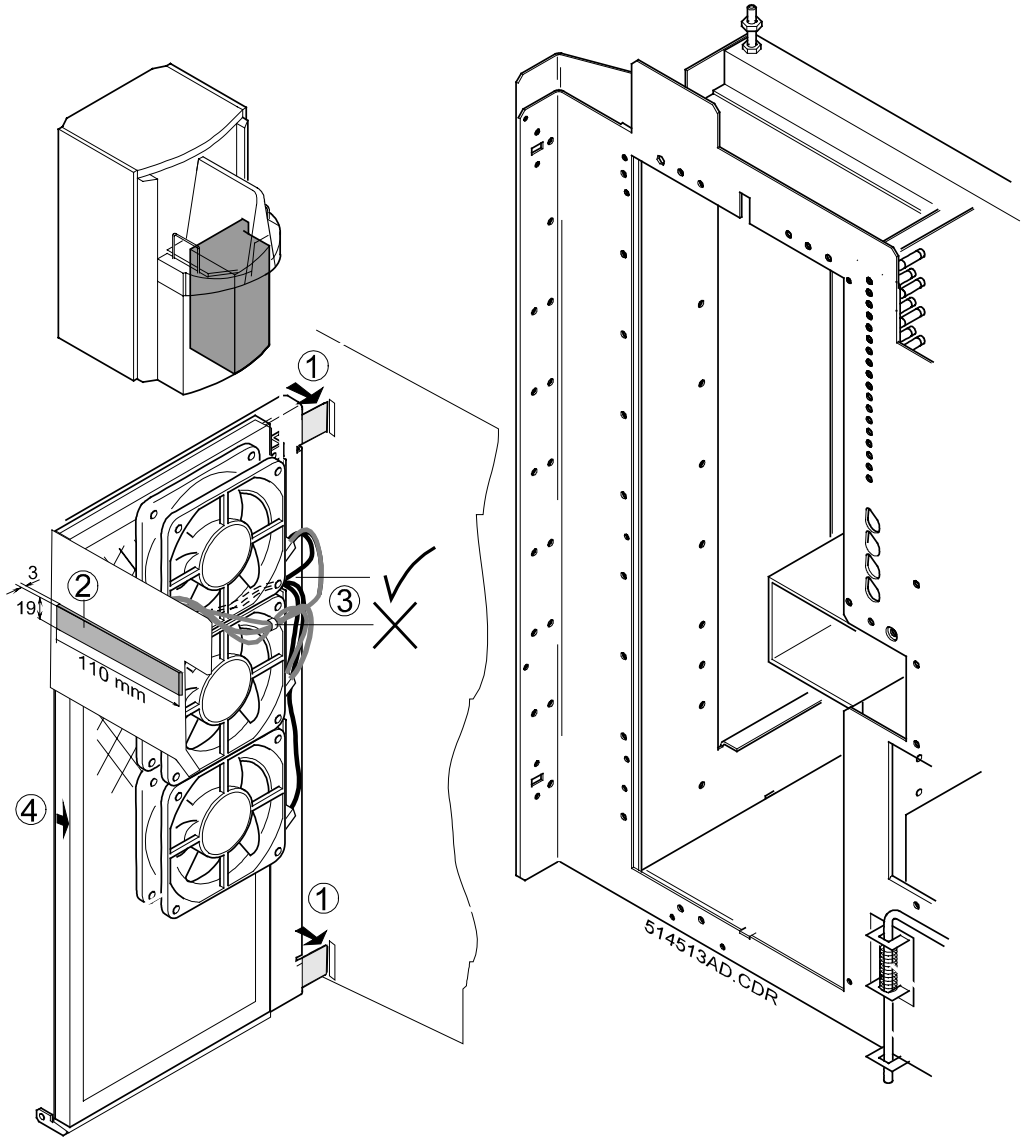
The pump unit generates rattling noise.

Vibrations at the lug / door slots

Cover plate touches the pump bracket

Fan wiring rubs against the fans

Bend the lugs slightly (approx. 6°) see Figure 6 / 1.

Attach a foam rubber strip (approx. 19 x 3 x 110 mm) at the pump bracket, see Figure 6 / 2.

Place the wires between the two fans, see Figure 6 / 3.

- Observe the correct positioning when inserting the fan filter, see arrow marks, Figure 6 / 4.

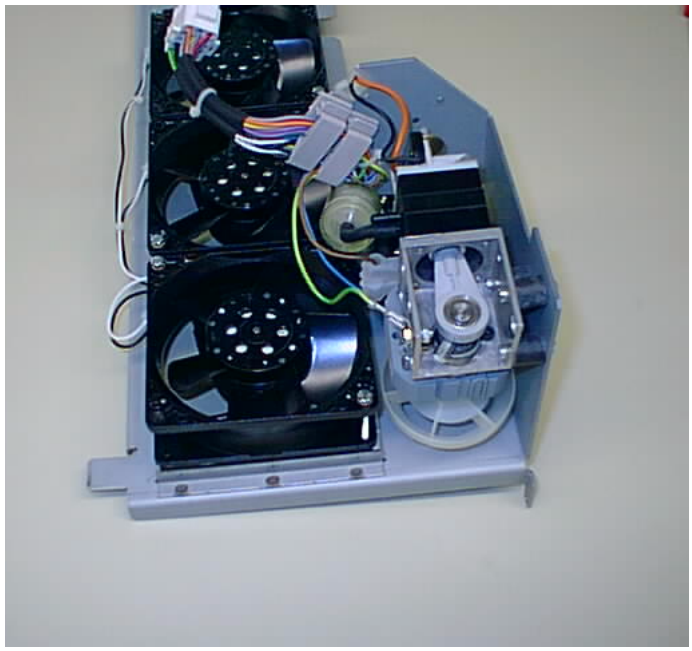
Figure 7

Pump wiring rubs against the fans

Fix the connection cable of the pump with the first clamp, already present, see

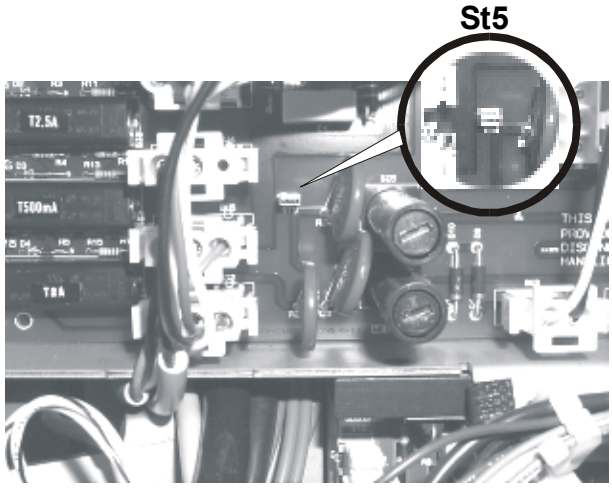
Figure 8

If this jumper is not removed, the varistors may possibly be destroyed.

To avoid problems when ADC Compact is being used with IT - ✳ mains remove the jumper on St5 of the Power Unit.

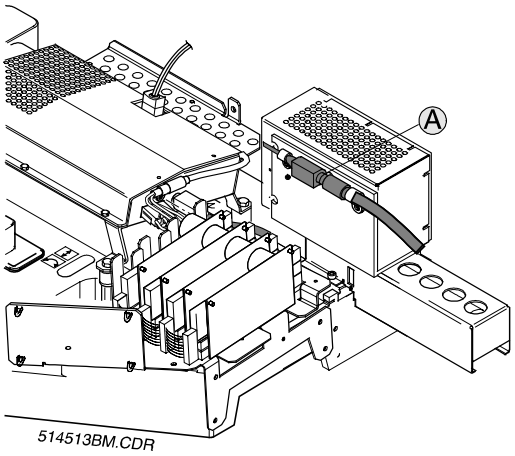
- Error message 20506
- no laser power although the laser beam is visible at the fiber optic monitoring device.

loose plug connection of the pin diode cable (see Figure 9 / A)

Secure the connection with adhesive tape.

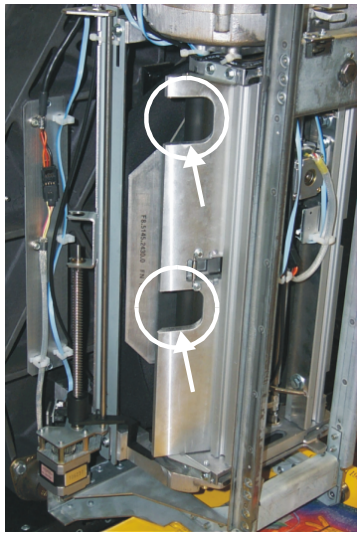
Figure 10

The rear suction arm touches the postscan bar when passing the opening (see circles). The correct suction position is not reached.

Variations in the production.

Installation of a modified postscan bar with a broader opening for the suction arms (see image beside).

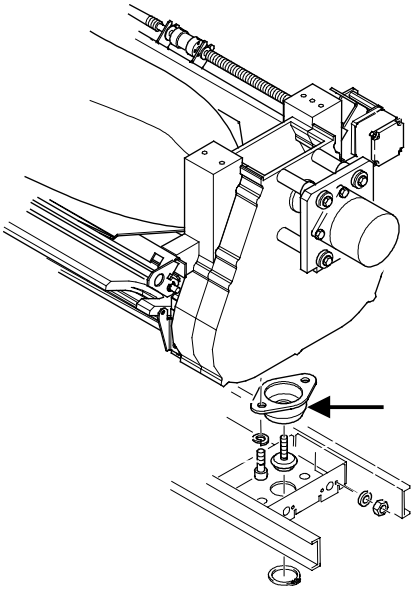
Figure 11

The front rubber buffer (see arrow) between rail and scanner may break down, whereupon the front part of the scanner lowers, the rollers are no longer parallel.

The front rubber buffer is too weak to stand the weight.

The front rubber buffer has been replaced by a new one having the same shape and dimensions but a harder rubber mixture (30 kg).

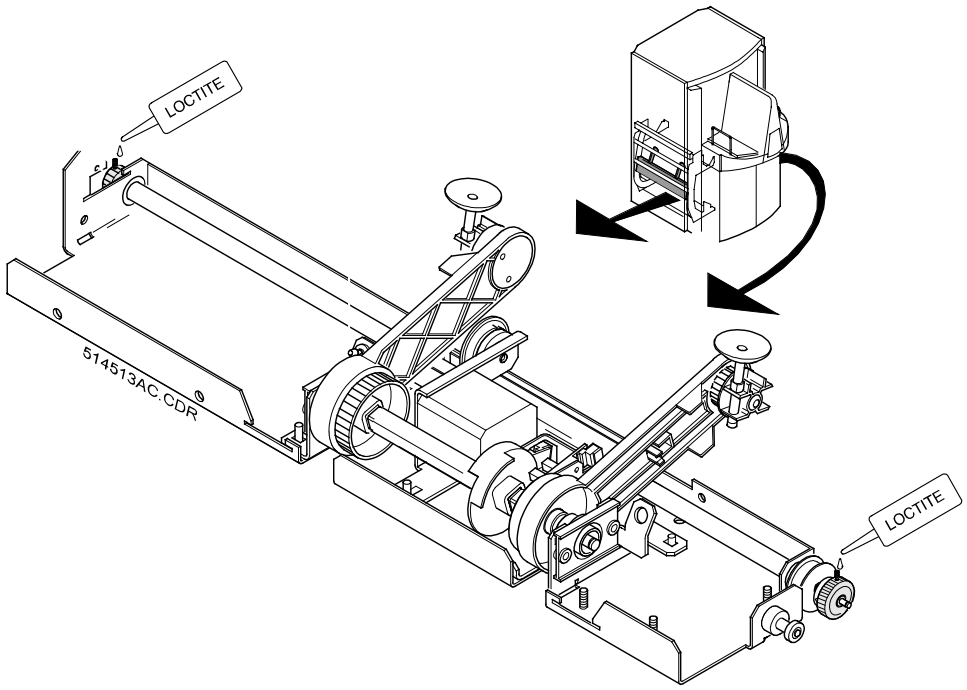
Figure 12

We noticed that after approximately 200 000 plate cycles the set screws on the toothed belt pulleys may loosen and fall out.

Secure the set screw of the 4 toothed belt pulleys (2 x IP-transport unit left, 2 x IP-transport unit right) with screw lacquer e.g. LOCTITE 243. This may be carried out during the next maintenance call.

- Pull the IP-transport units out.
- Undo the set screws (4x, screwdriver 1.5 mm)
  - ☞ There is some red marking lacquer on the set screws, however, this has no holding function.
- Put a droplet of screw securing lacquer onto the thread of the set screw.
- Tighten the screw again.
- Allow for the lacquer to dry according to the glue instructions.

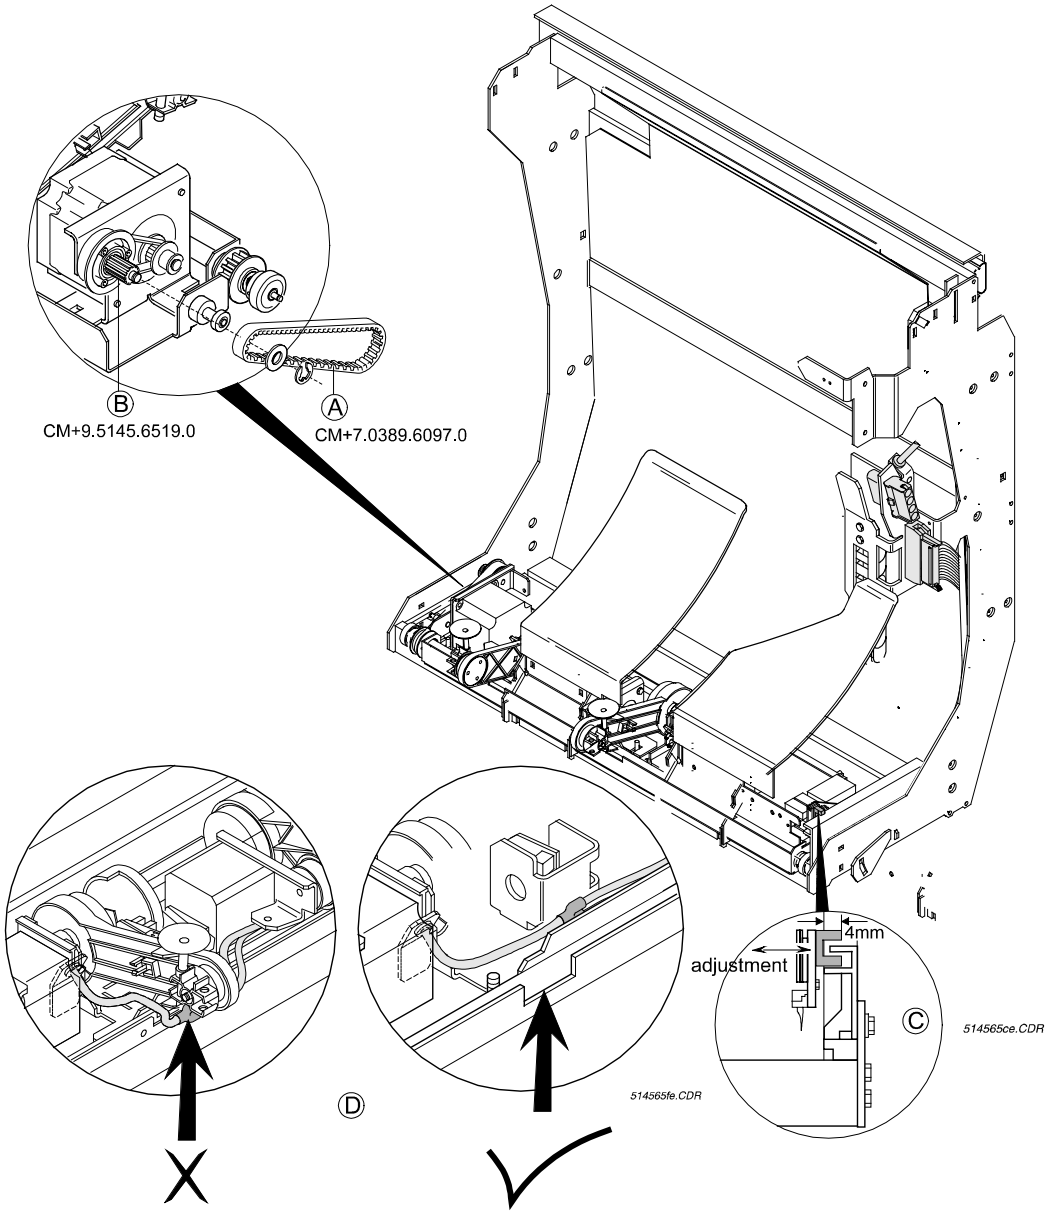
Stretched toothed belt in the IP transport unit right hand side, see Figure 13 / A

Stretched toothed belt in the IP transport unit left hand side, see Figure 13 / A

The light barrier does not run far enough into the toothed segment and thus the ACT. position is not detected. The carriage drives up to the mechanical stop, as a result the toothed belt can be stretched.

Home position of the suction bar (stop on the metal plate) is blocked by the vacuum hose or a cable.

- Replace the toothed belt see Figure 13 / A.
- Replace the damaged gear, see Figure 13 / B.

- Check the adjustment of the light barrier, if necessary bend the light barrier holder, see Figure 13 / C.
- Replace the toothed belt if stretched, see Figure 13 / A

Position the vacuum hose in such a way, that the suction bar can reach its nominal position, see Figure 13 / D.

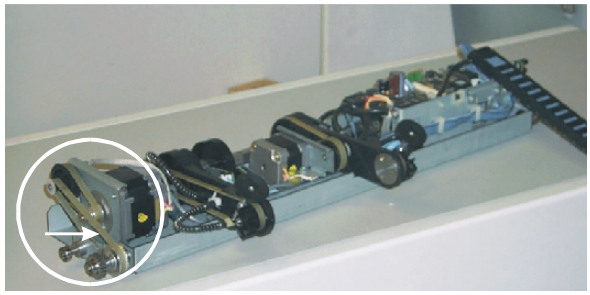
crafty or damaged transportation-belt

Installation of a modified robot:

With appearance of the aforementioned Error - Codes it is strongly recommended to exchange the robot carriage completely.

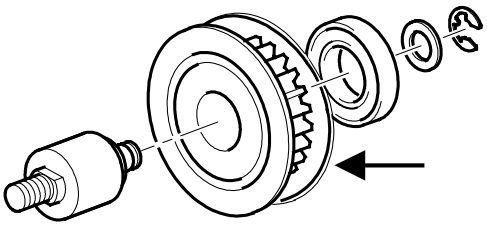
The toothed belt of the cassette clamp may possibly slip from the belt pulley.

The toothed belt has no hold when the humidity of the environment is too high.

An end plate (see arrow) preventing the toothed belt from slipping off has been attached to the axis.

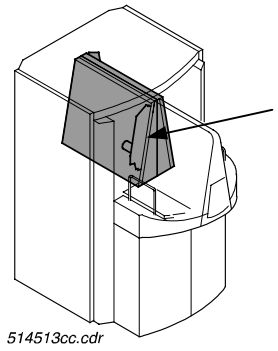
9.3 Installation of bigger Washers as Guide Discs

Affected machines:
5145/100 up to SN1194 (SN1191 OK)
5145/140 up to SN5068

Open up the cassette unit

and pull it out
